PERIODIC REVIEW

**Hilton Hotel Parking Garage
Facility Site ID#: 56642815**

**1305 6th Avenue,
Seattle, Washington**

TOXICS CLEANUP PROGRAM

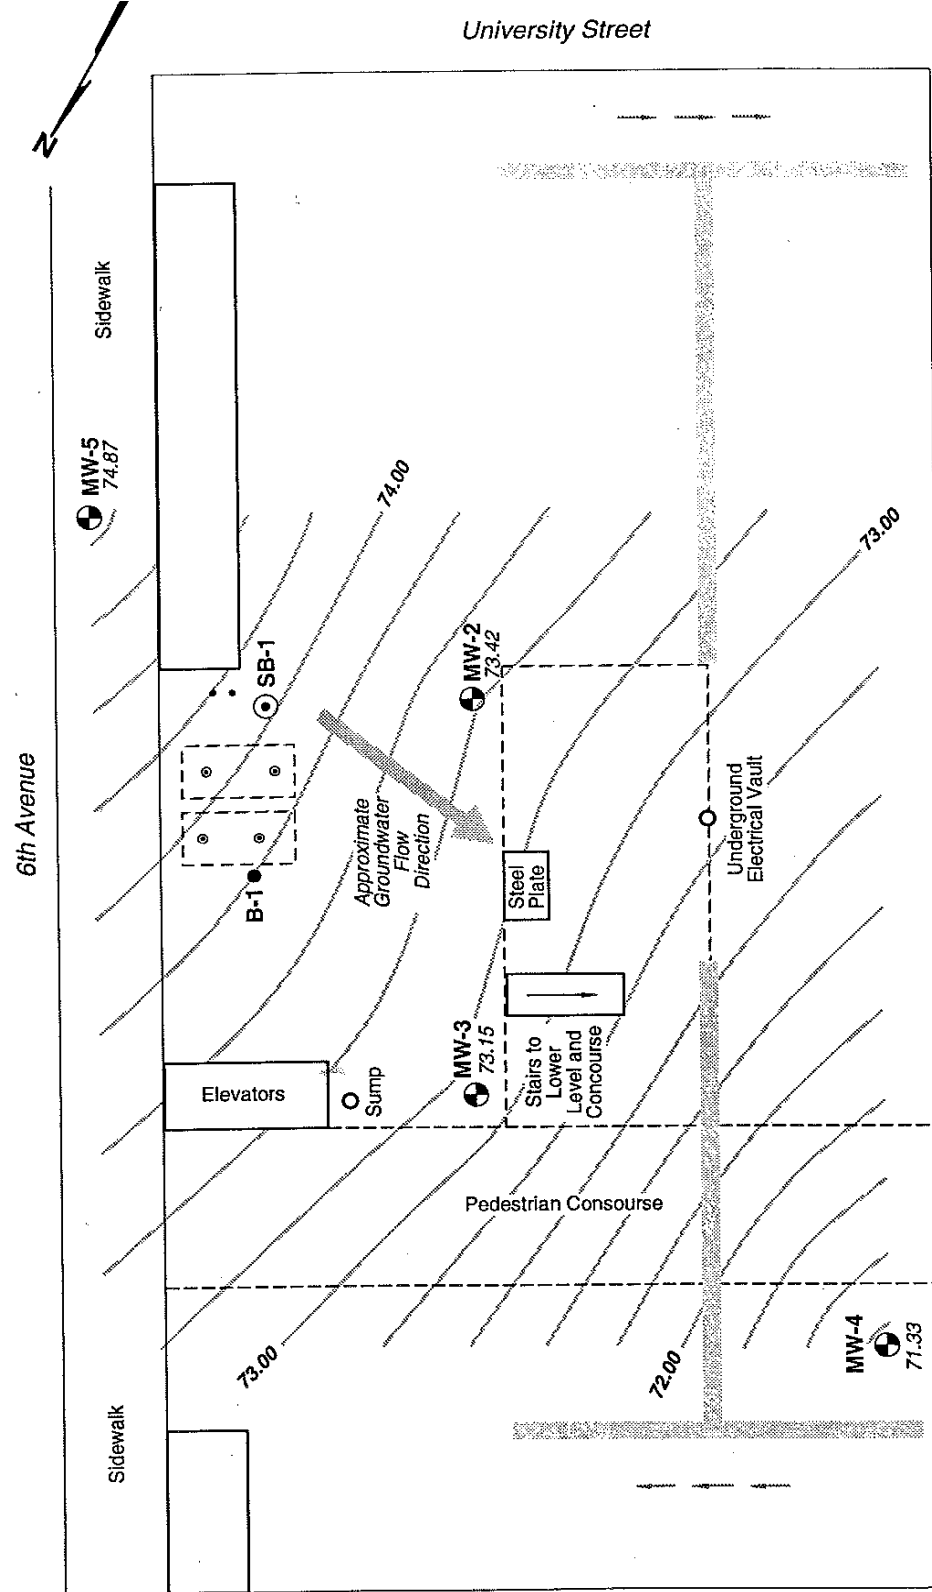
6.2 Site Plan

- 1). The Remedial Action resulted in remnant concentrations of TPH-G, present beneath the building foundations east corner of the site and south of the elevation shaft area as shown in Fig. 1 and;
- 2). This remnant and inaccessible contaminated soil is estimated to be about 300 cubic yards in volume.
